“MOTORGUIDE” ELECTRIC MOTORS

CARE AND MAINTENANCE GUIDE

Motorguide Inspection of Shock sail boat trolling motor installation

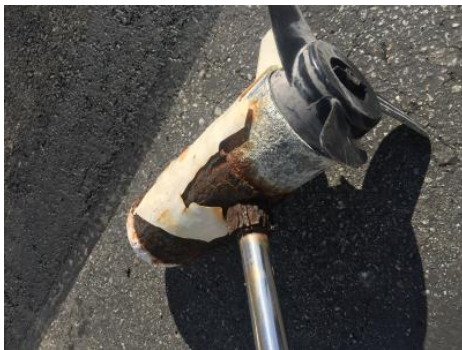
In this picture, we see extreme corrosion under the paint. This is classic electrolysis that occurred from the inside out.

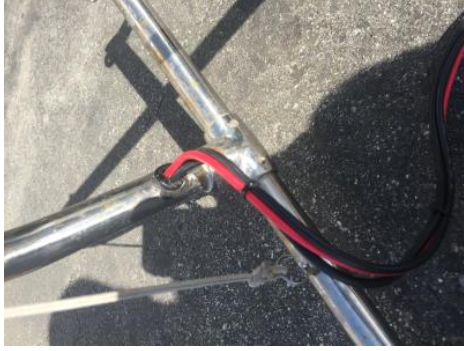
One possibility is the entry of salt water through the motor tube itself. This example has a grommet in place. However, other examples did not. If salt water is able to travel down this tube, it will in time cause a short to the system. Salt water is an excellent conductor.

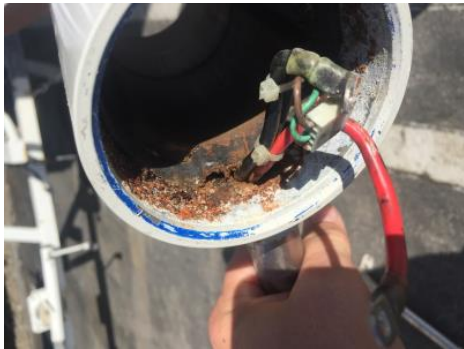
Here we see evidence that water is traveling down the tube. I feel the likely entry point is around these wires in the tube.

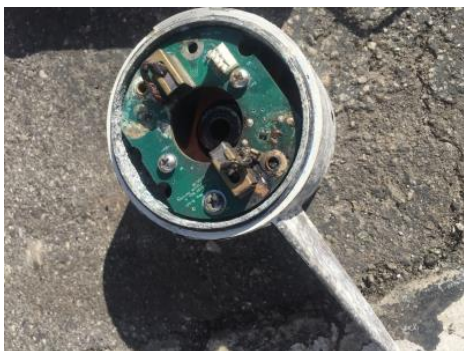
The water then shorts out this circuit board. Since there is 24 volts of DC power here, electrolysis occurs as voltage is put into the water. This is blowing the paint off of the motor casing.

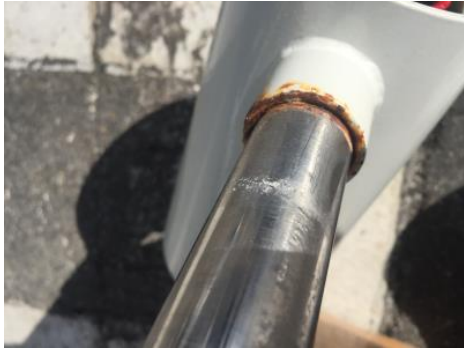
One other point to check is this joint. However, it is possible that the paint in this area is coming off. This “could” cause water to wick down the threads.

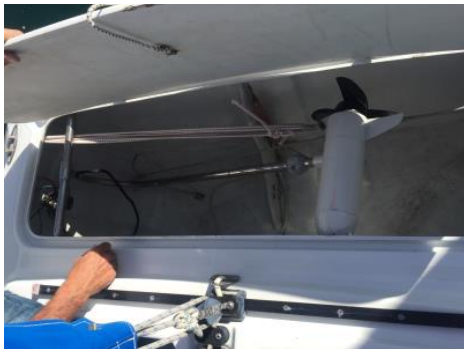
The entry point of the wire harness is different in some of these applications. It appears that the designer changed how he was fishing the wires down the tube. These points have to be properly sealed.

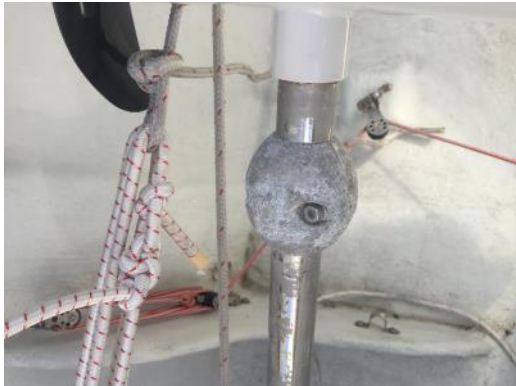
All applications need this anode installed. It will help. Make sure it is grounded to the casing tested with a meter.

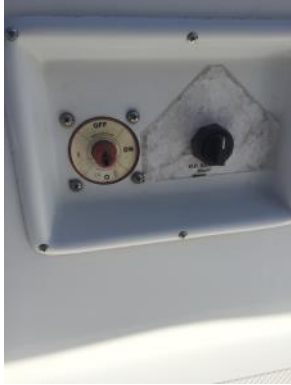
One item that could help is not running the motor at full throttle during operation. There is a possibility that at high speed, the motor is overheating. It is a distant possibility but perhaps the customer could consider to not use the high speed selection to help reduce this as a failure possibility.

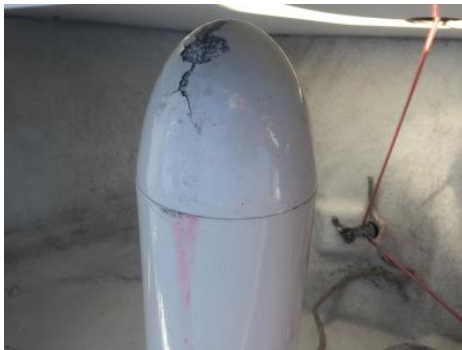
This damage needs to be repaired. Wherever there is a break in the paint, it needs to be properly sanded and re-painted. Corrosion is already starting on this unit as you can see. If it goes unattended, salt water may enter the motor casing through the O-ring seals. I did not see evidence of this, but I would have to inspect more to be sure.
